UNITED STATES ENVIRONMENTAL PROTECTION AGENCY
REGION IX – PACIFIC SOUTHWEST REGION
75 Hawthorne Street
San Francisco, CA 94105-3901

Re: Clean Water Act Pretreatment Inspection

**Region 9 Enforcement Division
75 Hawthorne Street
San Francisco, CA 94105
INSPECTION REPORT**

Inspection Date(s):	8/15/2018	Inspection Announced: No	
Time:	Entry: 10:47 a.m.	Exit: 2:35 p.m.	
Media:	Water		
Regulatory Program(s)	NPDES – Industrial Pretreatment Program		
Company Name:	Pacific Choice Seafood		
Facility Name:	Pacific Choice Seafood		
Facility/Site Physical Location:	1 Commercial Street		
(city, state, zip code)	Eureka, CA 95501		
Geographic Coordinates (latitude, longitude):	40.804615, -124.174840		
Facility/Site Contact:	David Bodiroga	Maintenance Manager	
	dbodiroga@pacseafood.com		
	707-442-2981 ext. 8514		
Industrial User Permit No:	37		
Publicly Owned Treatment Works (POTW):	City of Eureka (City)		
POTW Permit Nos.:	Elk River Wastewater Treatment Plant (CA0024449)		
Facility/Site Personnel Participating in Inspection:			
David Bodiroga	Pacific Choice Seafood	Maintenance Manager	707-442-2981 ext. 8514
Inspector(s):			
Sirese Jacobson (Lead Inspector and Report Author)	Signature:

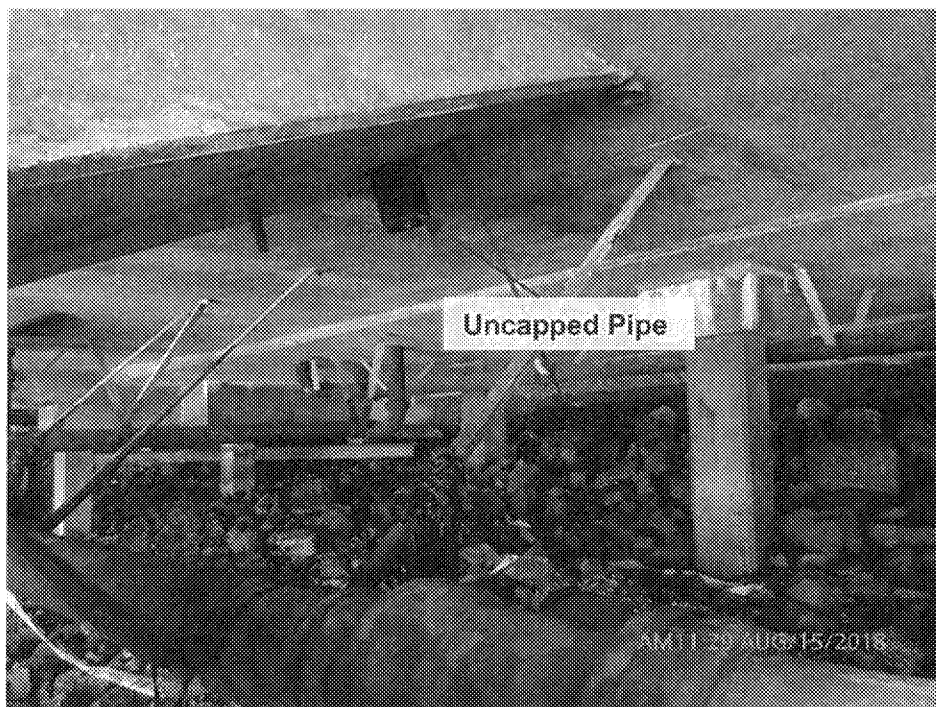
2. Beneath the facility's dock, the inspection team observed multiple vertical pipes (Photographs 3 and 6) coming down from the dock. Although no discharge was observed from these pipes, the pipes were not capped. The inspection team recommended that the facility cap these pipes to remove the potential for discharge.

Photograph 6. View of a pipe under the dock with no cap.

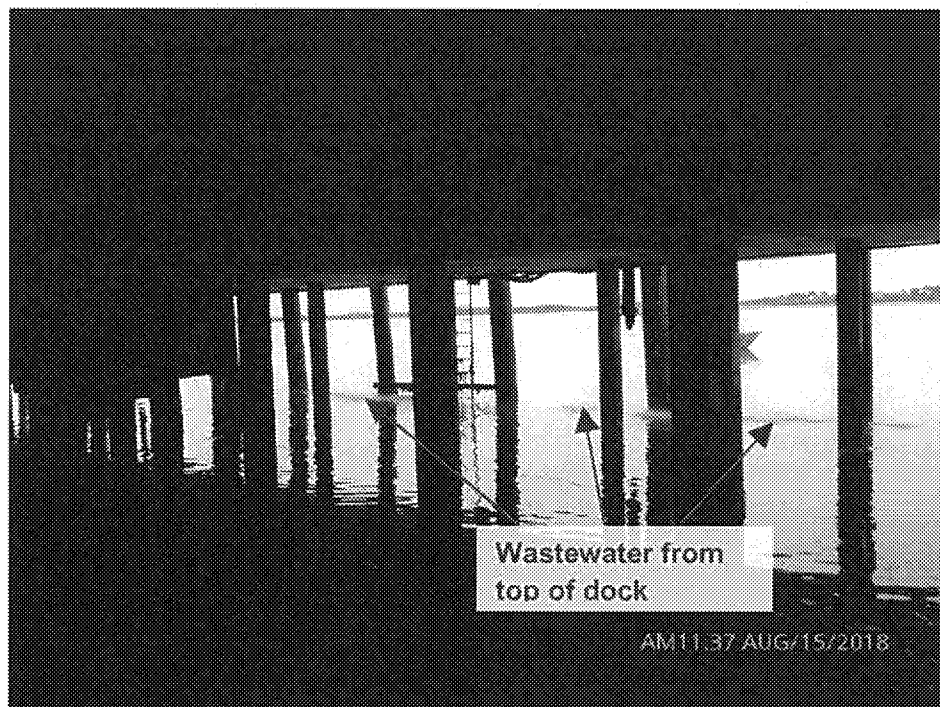
The inspection team proceeded to the facility's dock. The facility was rinsing oysters on the dock at the time of the inspection (Photograph 15). Rinse water from this process was observed flowing off the side of the dock into Eureka Slough (Photograph 16). According to the facility representative, the facility also unloads fish into a deicer on the dock. The fish, along with Eureka Slough water and ice are dumped into the deicer (Photograph 17). The fish are conveyed into a tub to be processed inside the facility. The ice and Eureka Slough water are dumped back into the Eureka Slough. The facility also unloads live crabs from the boats onto the dock and into totes. Hosing directs Eureka Slough water into the totes (Photograph 18). Overflow of Eureka Slough water from the totes flows off the side of the dock back into Eureka Slough. Earlier during the inspection, the inspection team had observed wastewater flowing over the side of the dock (Photograph 19). Refer to Item 5 in the *Areas of Concern* section of this report for additional information.

Photograph 19. View of the water coming off the top of the dock into the Eureka Slough.

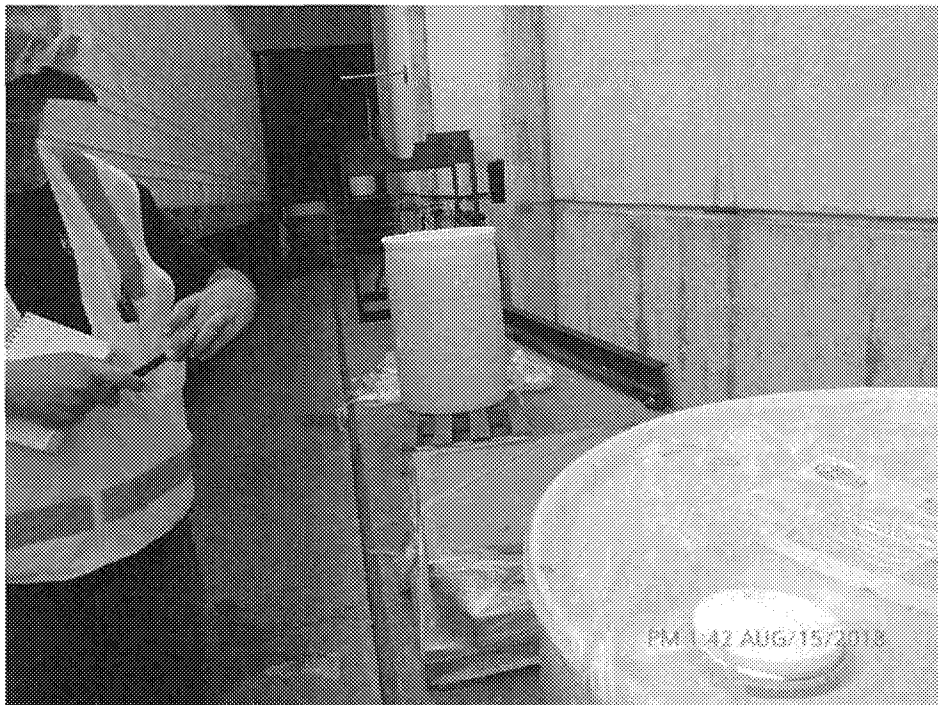
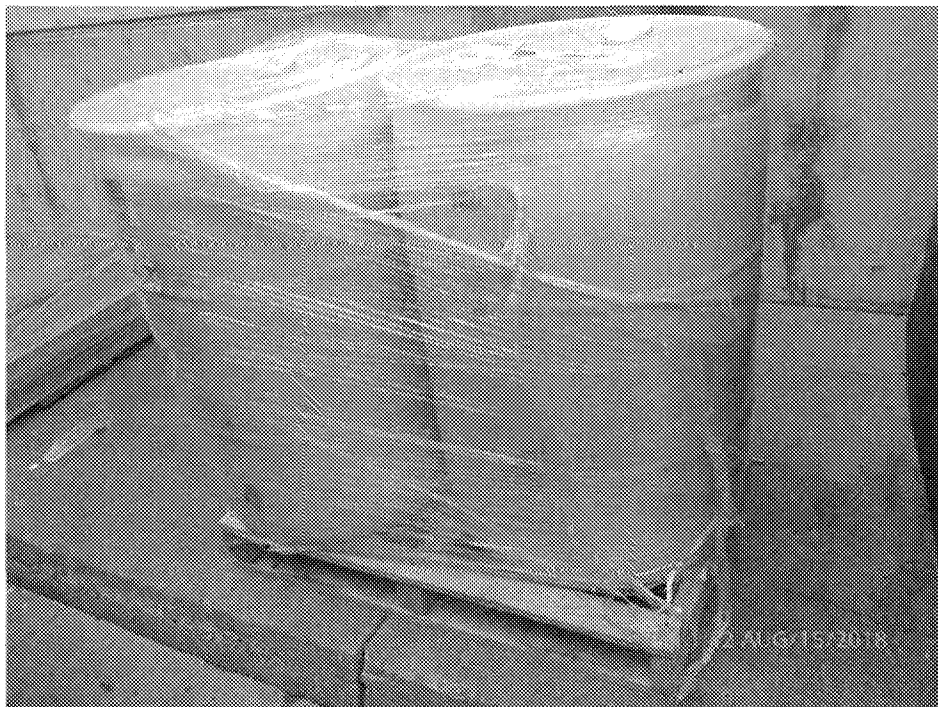
10. The facility was lacking secondary containment in the facility's outdoor chemical storage area (Photographs 26-28). Part 1.C of the facility's discharge permit states, "[t]he permittee shall remove or double-contain any hazardous materials, stored near drains, in a manner which will ensure that accidental spills or leaks will not enter the storm drain or sanitary sewer." The facility is required, as stipulated in its discharge permit, to ensure that all chemical drums in the outdoor chemical storage area have secondary containment.

Photograph 26. View of the outdoor bulk chemical storage area.

Photograph 27. View of chemical storage drums located outside the facility's production building and not within secondary containment or in a covered area.

Photograph 28. Another view of chemical storage drums located outside the facility's production building lacking secondary containment and a covered structure.

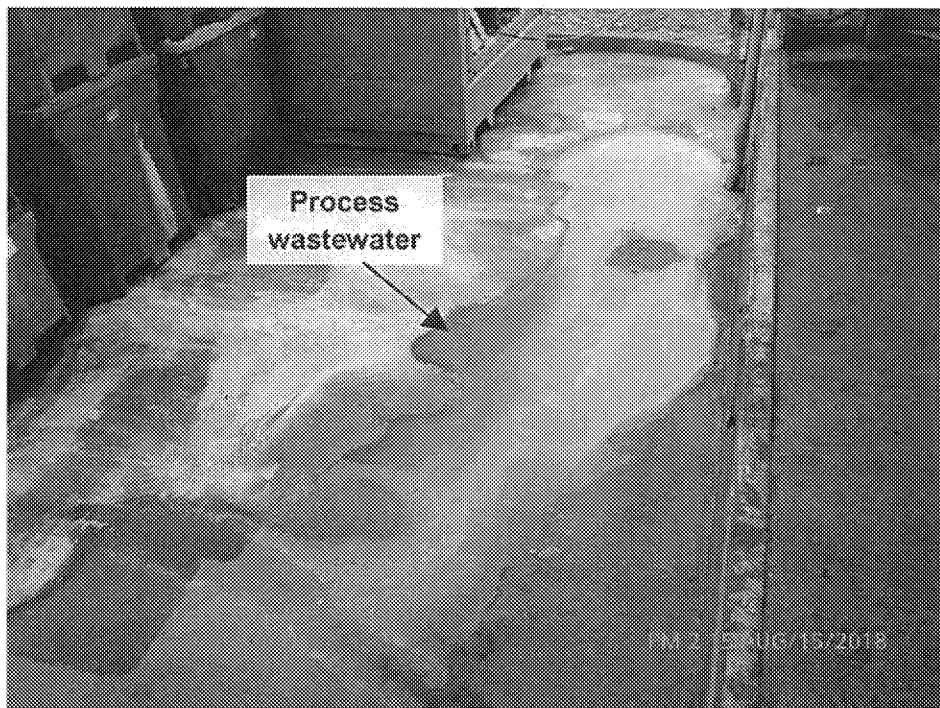
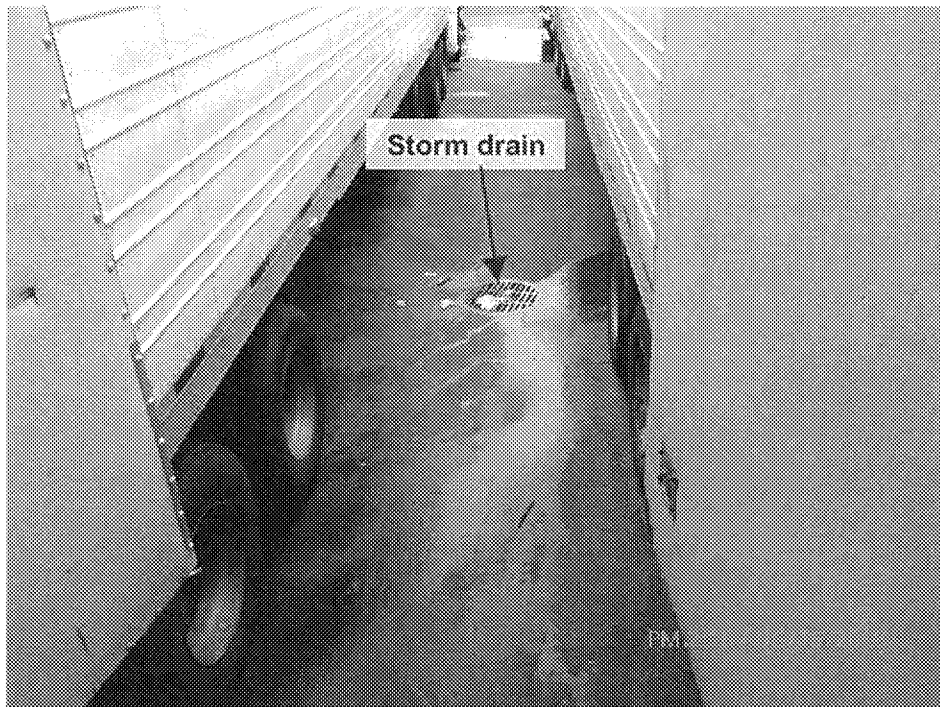
12. The inspection team observed a storm drain in the loading dock area (Photograph 35). Process wastewater from shrimp processing was observed near the storm drain (Photographs 32-34). In addition, oily water was observed on the platform above the driveway with the storm drain (Photograph 33). During a rain event, this wastewater has the potential to reach the storm drain. Subsection 54.040.A of the City of Eureka's Stormwater Ordinance (Ordinance No. 705 -C.S) states "No person shall discharge or cause to be discharged into the storm drainage facilities or watercourses any materials, including but not limited to pollutants or waters containing any pollutants that cause or contribute to a violation of applicable water quality standards, other than storm water." In

addition, Part 1.C of the facility's discharge permit states, "[t]he permittee shall remove or double-contain any hazardous materials, stored near drains, in a manner which will ensure that accidental spills or leaks will not enter the storm drain or sanitary sewer."

Photograph 32. View of fish bins stored in the facility's loading dock. Wastewater was observed flowing from this area to the storm drain shown in Photograph 35.

Photograph 33. View of process wastewater and oily liquid present in the facility's loading dock.

Photograph 34. Another view of the process wastewater shown in Photograph 35.

Photograph 35. View of a storm drain located nearby the locations shown in Photographs 32 – 34. Liquid is visible entering the storm drain.
